Durham NHS Treatment Centre

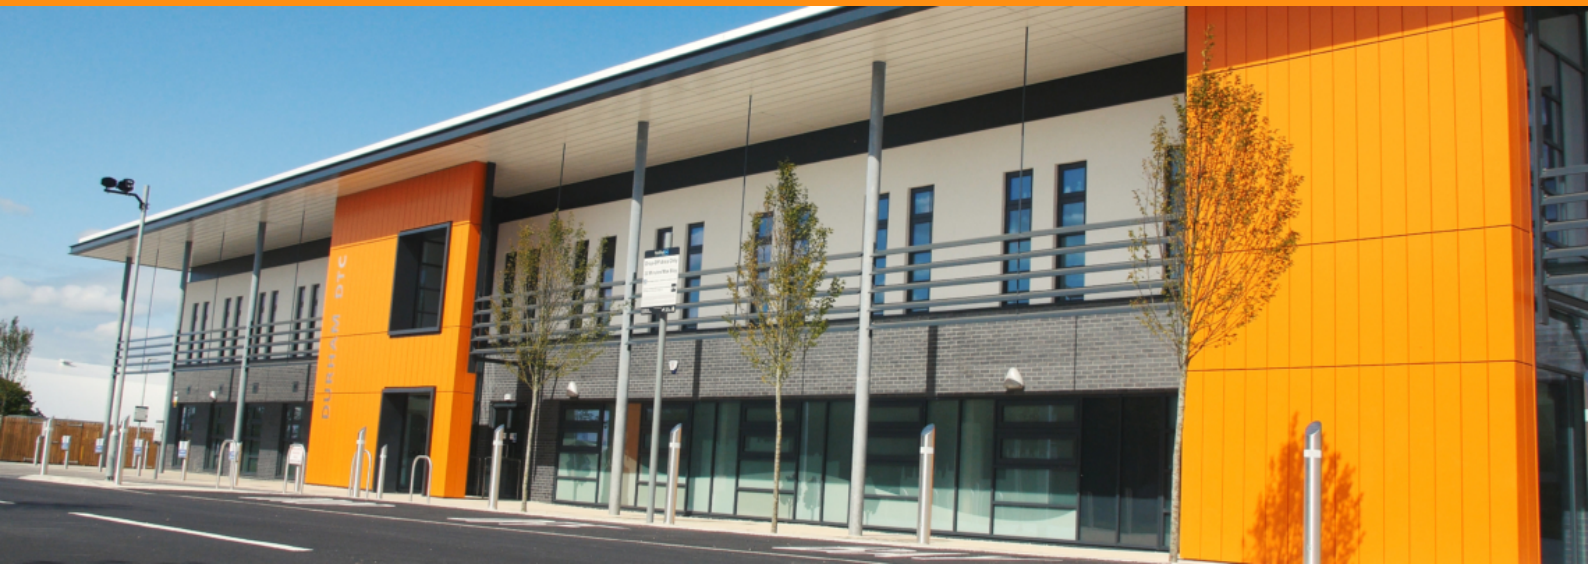
At Durham's NHS Diagnostics and Treatment Centre the designers diagnosed a potential overheating issue caused by direct sunlight through the windows. WPL's antidote was the inclusion of AF200 aerofoil system over the glazed areas.

The spans were too great for our standard install, so we introduced a mid-support point hung from the roof steels using only a 12-millimetre steel rod. The end result was neat straight lines forming the protective barrier, relieving the otherwise uncomfortable symptoms of direct sunlight.
